# A Historical and Archaeological Study of Caludon Castle, Wyken, Coventry

A report submitted for the Certificate in Archaeology at Warwick University

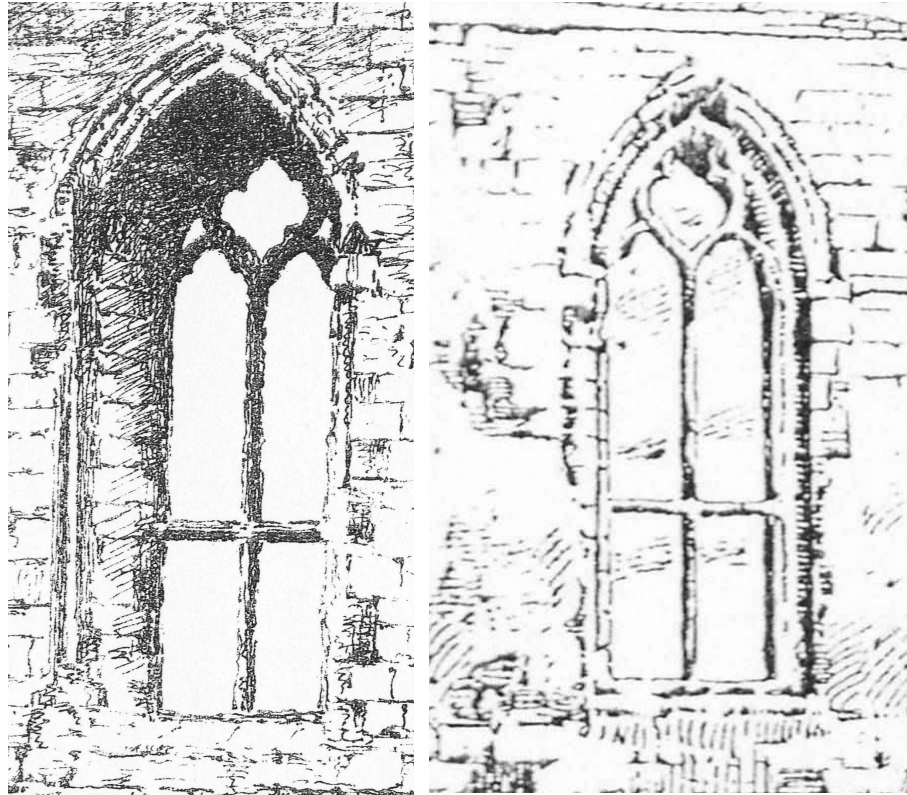
left: detail from drawing “Remains of Banqueting Hall, Caludon Castle, Near Coventry by David Waters  
right: detail from drawing “Remains of Banqueting Hall, Caludon Castle” by C. Hentschell

The design of the windows is depicted in a drawing of the South face by Walters (10) and one of the North face by Hentchell (1) in the 1880s. Both show tracery and mullions typical of the decorated gothic style. A postcard photograph (3) from the 1930s supports this.
